In collaboration with H.K.O. Isolier- und Textiltechnik GmbH, Sonnen Stark GmbH is presenting a specially developed fire protection fabric that serves as an effective fire protection barrier between the PV system and the flat roof:

## PYROFAB® Sol

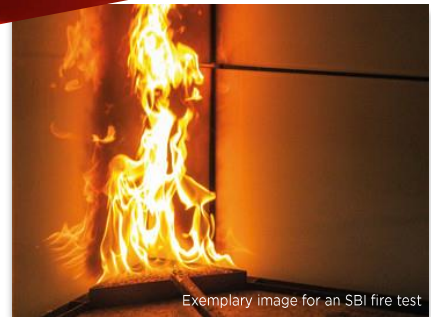
Fires can occur in PV systems in different ways. One common cause is electrical faults in the system that cause a short circuit. This may be due to inadequate installation, faulty cabling or insufficient maintenance.

Faulty or damaged solar modules caused by external influences such as hail or storms are another potential trigger for fires. Fires can also occur if there is insufficient protection against overheating, for example due to inadequate ventilation or overloading of the system.
